## Extract of property visit photos to owners

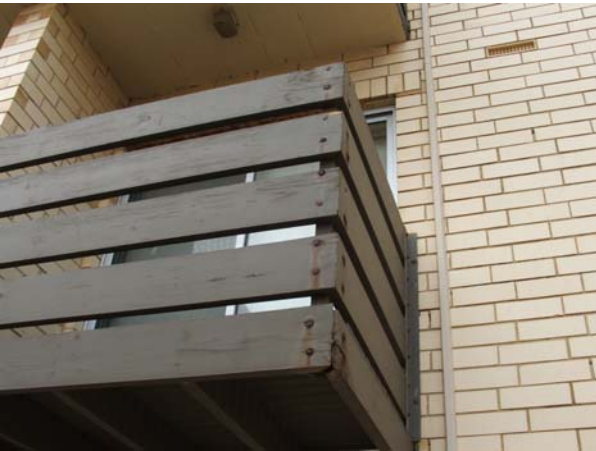
Rusting of steel bolts and some rot evident on this balcony.

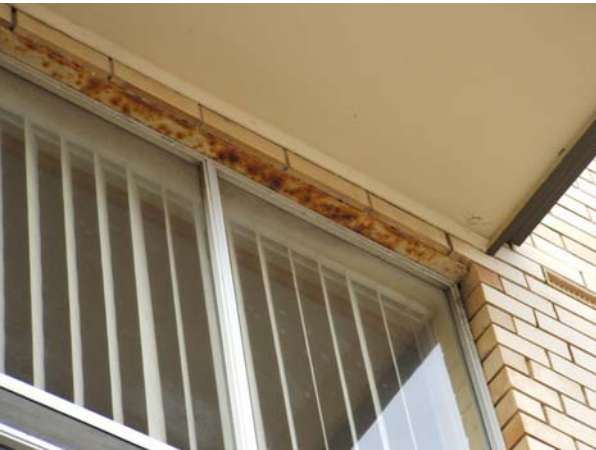
View of window lintel - all show signs of extensive rusting.
